RE: Progress report for November 2008 activities - Hecla Mining Company Apex Site (EPA ID No. UT982589848, Docket No. RCRA-8-99-06)

**MEMORANDUM TO:** Apex File  
**COPIES TO:** distribution  
**FROM:** Paul Glader  
**SUBJECT:** Progress Report No. 55 for period ending November 30, 2008; Pond 2 Final Closure - Apex Site, Washington County, Utah

# Annual Site Inspection Summary Sheet - Apex Site - Pond 2

TO: Paul Glader (Hecla Mining Company)  
FROM: Doug Gibbs (Monster Engineering Inc.)  
DATE: 11/4/08  
SUBJECT: **Surface Monument Survey Data Review – Apex Site**

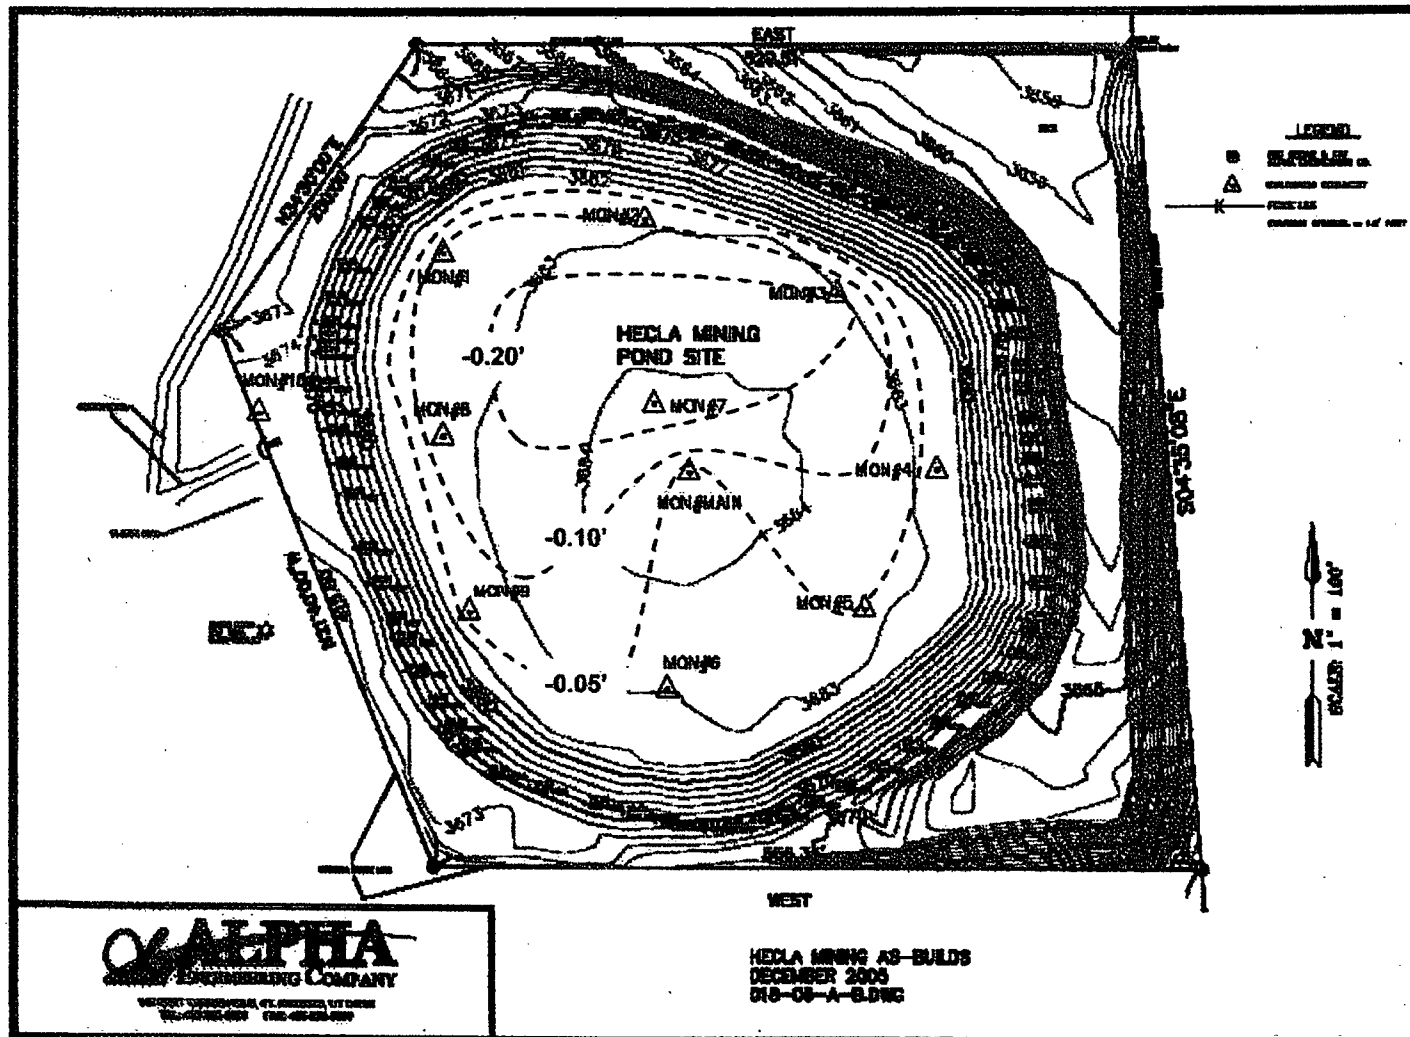
### Apex Pond 2 - Settlement Monument Elevations

The October 2008 survey data analysis is being completed – no settlement changes have been noted.

Based on data collected to date, MEI recommends that Hecia continue with their current plan and collect elevation data semi-annually. Please contact me if you have any questions concerning this review.
